INSTALLATION INSTRUCTIONS

Series 825YD, 826YD Reduced Pressure Zone Assemblies Reduced Pressure Detector Assemblies Sizes: 2½" – 10" (65 – 250mm)

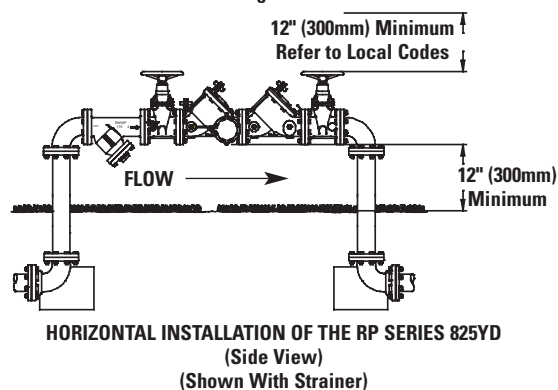
Figure 1

HORIZONTAL INSTALLATION OF THE RP SERIES 825YD
(Side View)
(Shown With Strainer)

3. The valve assembly must be installed where it is accessible for periodic testing and maintenance. Clearances shown in the installation views apply to exterior, interior and pit/vault installations and are only recommendations. These minimums do not apply to removable protective enclosures. Refer to local codes for actual requirements in your area.

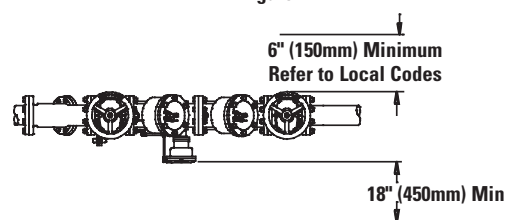
Figure 2

HORIZONTAL INSTALLATION OF THE RP SERIES 825YD
(Top View)
(Shown With Strainer)
